Manhole Inspection Summary

Manhole # S41CC_056MH

Insp Date: **12/6/07 12:56 PM**

Location Address: **842 n.eden**

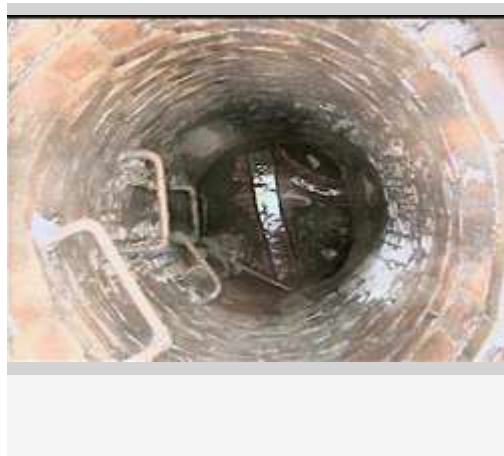
Top View

Condition: **Cracked**

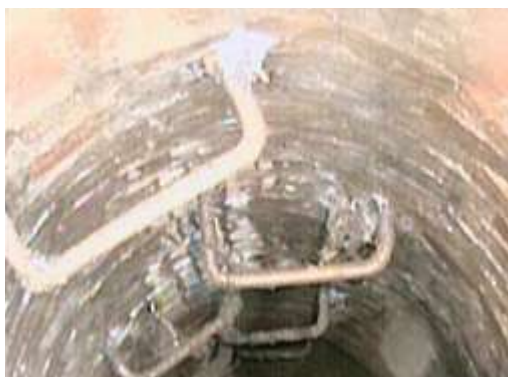
Defect 1

Count: **7** Missing: **0** ☒ Corroded

steps

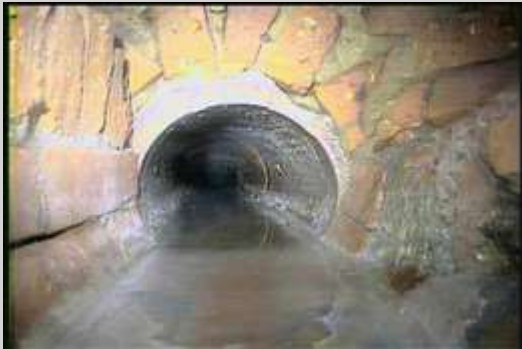
12 O'Clock Outflow

8 in. Circular Gravity Sewer
Pipe Out @ 12 O'Clock

Pipe Material: **Clay** ☐ Pipe Lined

Invert Depth: **13.40** (ft.) Flow Characteristics: **Slow**

Infiltration: **None** Pipe Seal Cond: **Unknown**

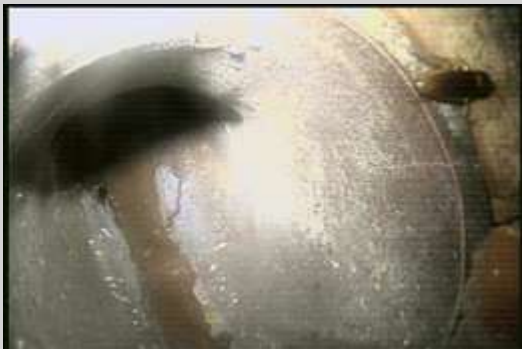
3 O'Clock Inflow

8 in. Circular Gravity Sewer
Pipe In @ 3 O'Clock

Pipe Material: **Clay** ☐ Pipe Lined

Invert Depth: **12.75** (ft.) Flow Characteristics: **Slow**

Infiltration: **None** Pipe Seal Cond: **Unknown**

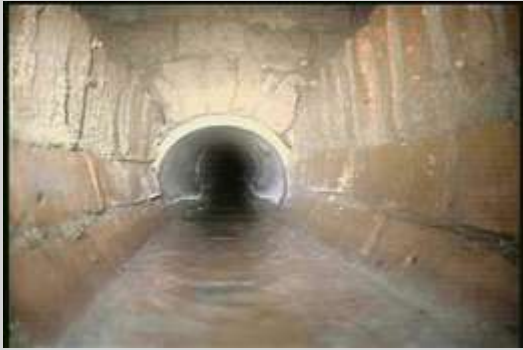
6 O'Clock Inflow

8 in. Circular Gravity Sewer
Pipe In @ 6 O'Clock

Pipe Material: **Clay** ☐ Pipe Lined

Invert Depth: **13.25** (ft.) Flow Characteristics: **Slow**

Infiltration: **None** Pipe Seal Cond: **Unknown**
